Detecting Distribution Transformer Faults

Increasing Distribution System Productivity

**Written and Edited By:
Wayne Clark, P. Eng.
Senior Energy Industry Consultant**

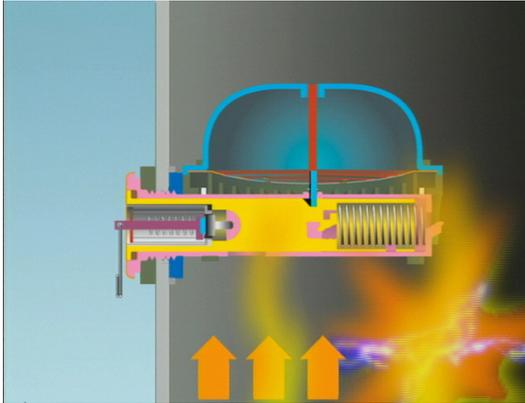
Figure 1

Prior to operation, the pressure detecting membrane and its trigger shaft (red and blue vertical rod) are in the lowered position, locking the indicator (yellow) in place. The large spring on the right side stores the energy to push the indicator out; the small coaxial assembly on the left is the pressure relief device (PRD).

Figures 1 and 2 show a cross sectional drawing and mode of operation.

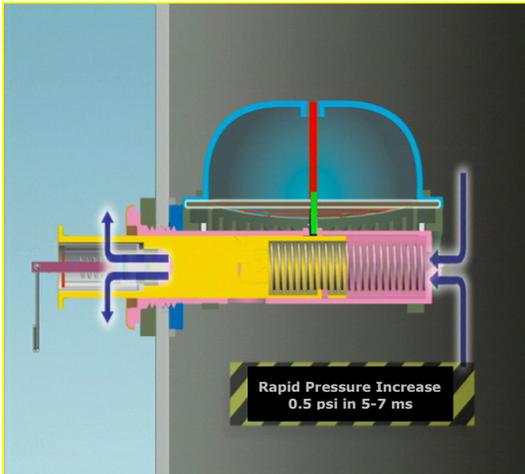
Figure 2

When the membrane reacts to pressure pulse caused by an internal fault, it moves up, carrying the trigger shaft with it (red and green). This releases the indicator, which is pushed out by the spring. Once this happens, pressure is relieved through the IFD. The blue arrows indicate the flow of gas through the indicator assembly.
